PB99-910401  
NTSB/AAR-99/01  
DCA94MA076

## AIRCRAFT ACCIDENT REPORT

UNCONTROLLED DESCENT AND COLLISION WITH TERRAIN  
USAIR FLIGHT 427  
BOEING 737-300, N513AU  
NEAR ALIQUIPPA, PENNSYLVANIA  
SEPTEMBER 8, 1994

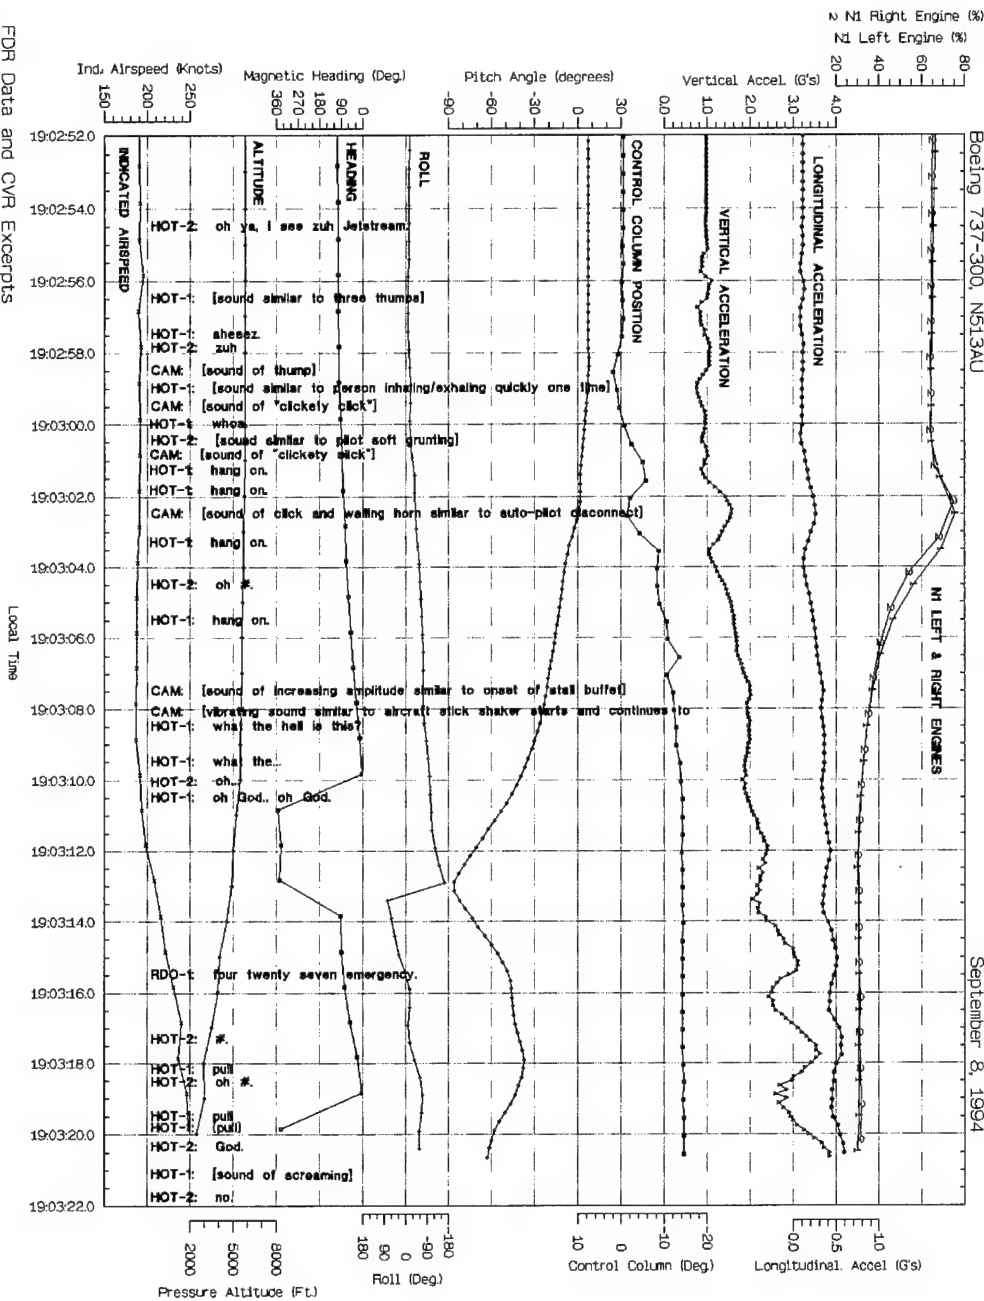
Figure 1. FDR data during the final 30 seconds of USAir flight 427.

FDR information revealed that, just before 1903:03, the airplane's left bank angle had increased to about 43°, the airplane had begun to descend from its assigned altitude of 6,000 feet msl, the control column had started to move aft, and the airspeed started to decrease below 190 knots. Less than 1 second later, the CVR recorded the sound of the autopilot disconnect horn. During the next 5 seconds, the FDR recorded increasing left roll, aft control column, decreasing altitude, and a decreasing airspeed to about 186 knots.

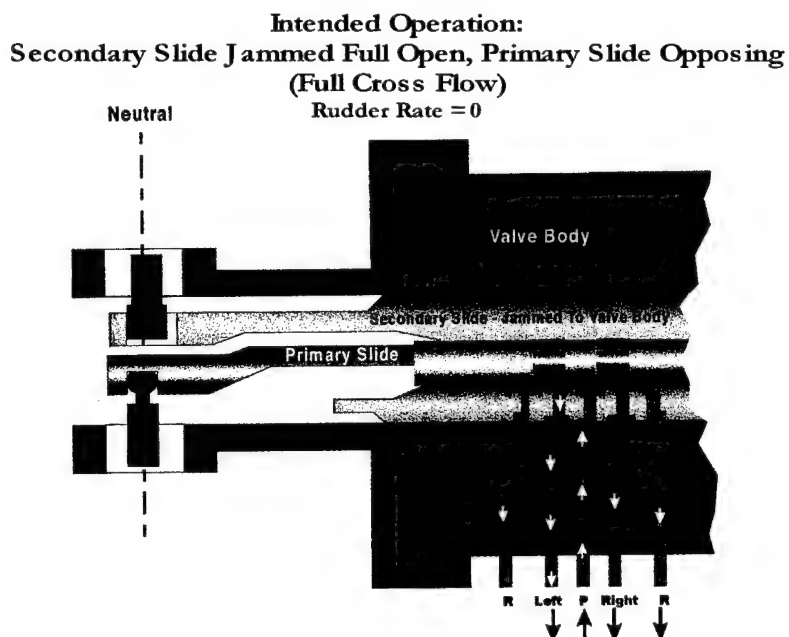
**Figure 16.** PCU servo valve intended operation with the secondary slide jammed to the servo valve housing and primary slide opposing.

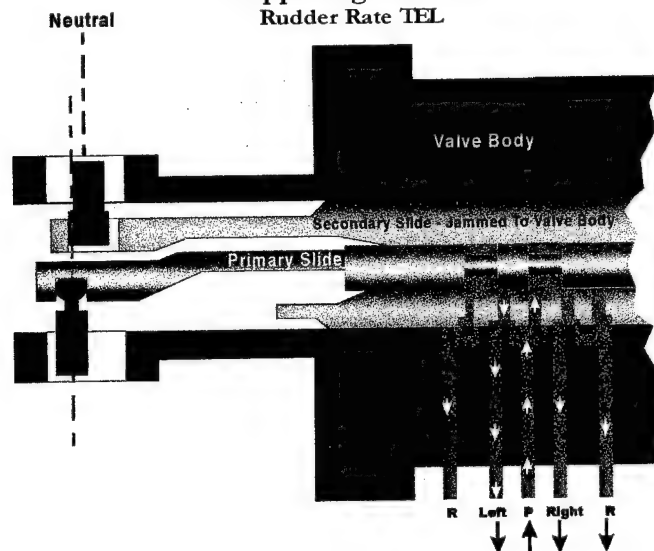
**Newly Discovered Failure Effect:  
Secondary Slide Jammed Full Open, Primary Slide Over-Stroke  
In Opposing Direction  
Rudder Rate TEL**

**Figure 17.** PCU servo valve with the secondary slide jammed to the servo valve housing and the primary slide in the overtravel condition.

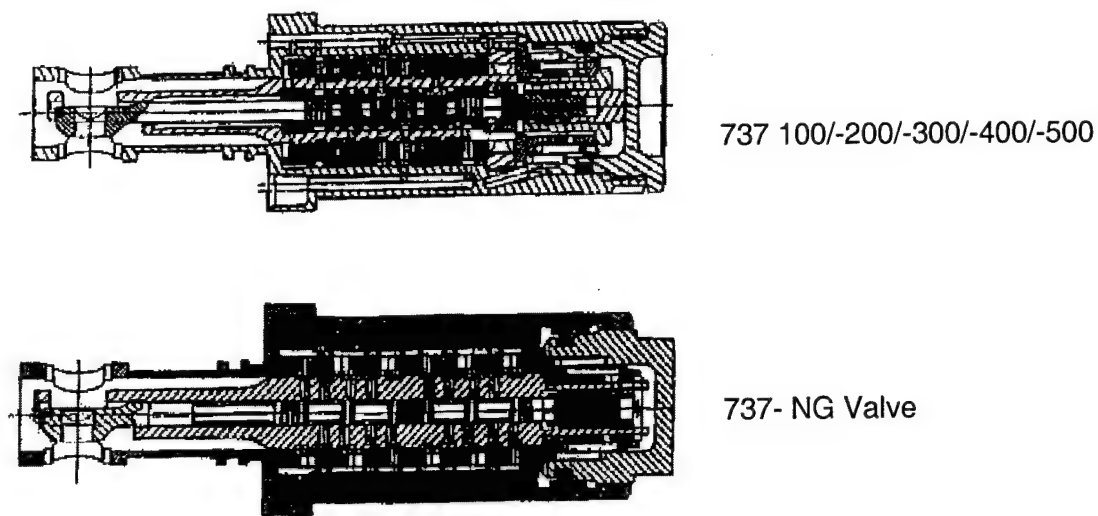
single piece rather than built up by a group of smaller parts. Figure 31 shows the 1998 redesigned servo valve for both the earlier 737 series airplanes and the 737-NG airplanes.

**Figure 31.** Parker's 1998 redesigned servo valve for 737 airplanes.
